SERVICE BULLETIN REVISION TRANSMITTAL SHEET

TITLE: WINGS - GENERAL - ONE TIME INSPECTION OF TAPERLOK BOLT AT

WING TO FUSELAGE JUNCTION.

This page transmits Revision No.03 of Service Bulletin No.A320-57-1131

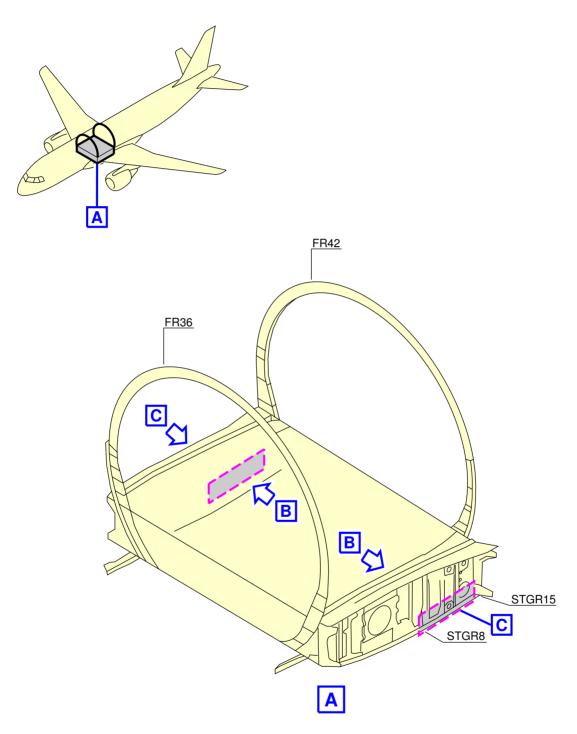
Figure A-FBAAA - Sheet 01 Inspection of the Fasteners

- 1 If taperlok gage fit and move:
 - <u>a</u> Do a visual inspection of the thread to determine the cause of thread marks found:
 - <1> If thread marks are found caused by an incorrect installation:

- <a> Apply SUBTASK 571131-833-019 001 Replace the Taperlok with the Next Nominal Diameter Taperlok on the LH Side before next flight.
 - <2> If no thread marks are found caused by an incorrect installation but thread was damaged during the nut removal:

- <a> Apply SUBTASK 571131-833-019 001 Replace the Taperlok with the Next Nominal Diameter Taperlok on the LH Side before next flight.
 - <3> If no thread marks are found caused by an incorrect installation and thread was not damaged during the nut removal:

- <a> Apply SUBTASK 571131-833-017 001 Replace the Nuts on the LH Side before next flight.
- If the taperlok gage do not fit and move but thread was damaged during the nut removal:

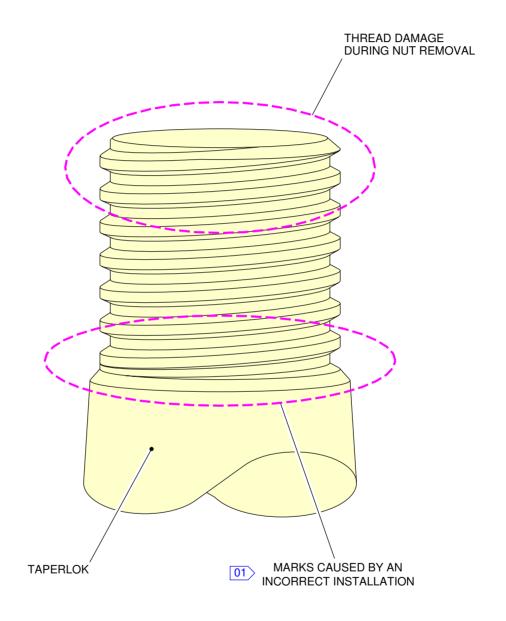
THREAD DAMAGE

01) FOR MORE INFORMATION OF THE CRITERION MARKS REFER TO THE BOOKLET 06-0009
